## BMW TRUNK EXTENSION CABLE REPAIR

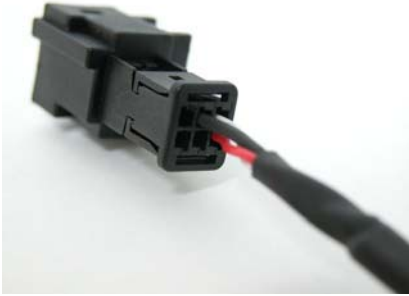
**Step 1.** If connected disconnect 3-pin and 6-pin connector from BMW CD-changer plugs.

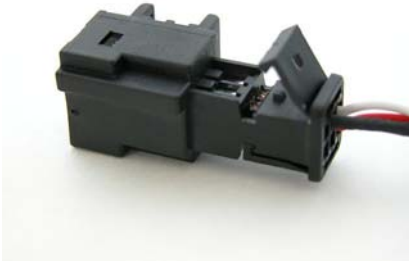
**Step 2.** Locate tab on top side of 6-pin connector on side nearest to the black ground wire.

**Step 3.** Pop plastic locking-tab open.

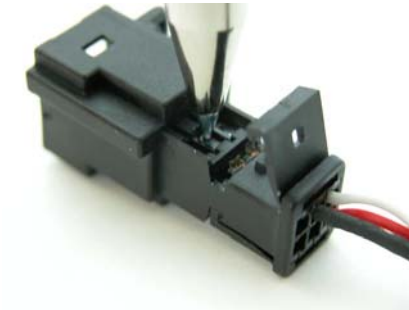
**Step 4.** Use ball point pen or other similar tool to press down on locking metal tab that corresponds to the black ground wire.

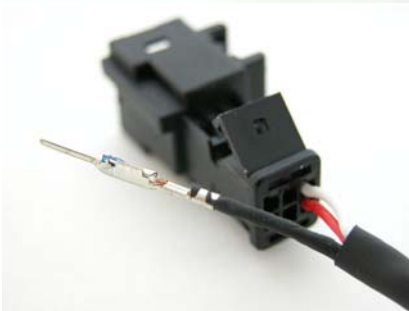
**Step 5.** Pull out black wire from the back of the 6-pin connector. Wire should easily pull out. If any force is needed to pull wire, please repeat step 4.

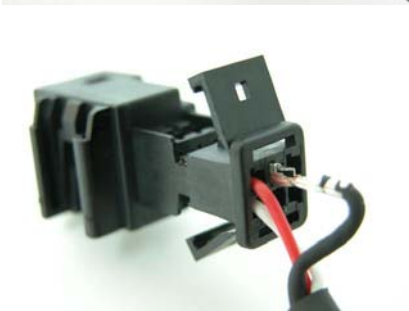
**Step 6.** Lift the other plastic tab open as done in step 3.

**Step 7.** Reinsert metal pin into position #2, located next to the red wire.

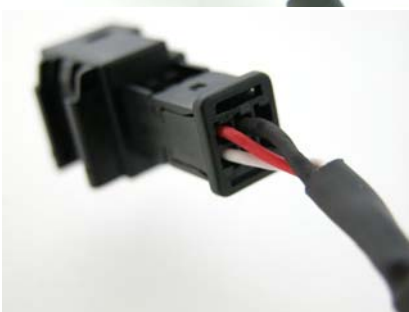
**Step 8.** Make sure pin is fully inserted and close both tabs until they pop closed.

Compare modified cable to the cable pictured and reinstall in vehicle.
